- Subject:** Maintenance instruction for aileron adjustments
- Serial number applicability:** All ASW 20 and ASW 20 L
- Compliance:** None, only if the glider displays a tendency to turn in a particular direction from straight and level flight.
- Reason:** During straight and level flight with the controls free, the pilot observes that the glider turns to a direction, or constant control pressure is necessary to keep it in straight flight.
- Action:** It is recommended to conduct the following measures in the sequence as described below:
- 1.) Select flap setting 1 (-11°) and check whether the control deflections as per flight and operation manual are achieved in full.

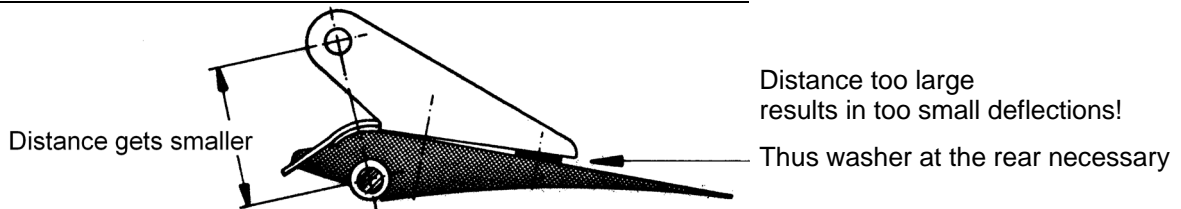
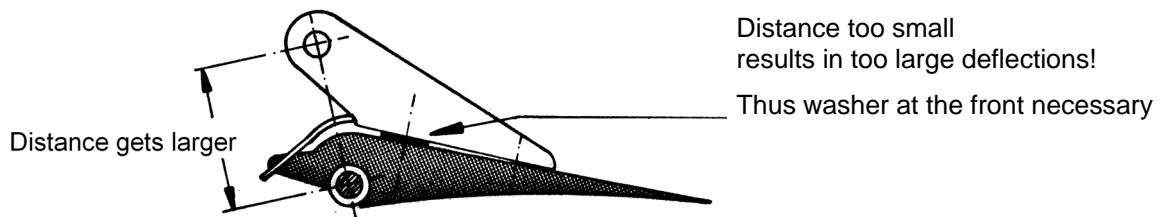
- a) Move the control column in flap setting 3 (0°) until movement is blocked by the control stops. In case ailerons or flaps deflect significantly further on one wing, different linkage arms are the likely reason. The problem can be solved by placing washers as per sketch below.

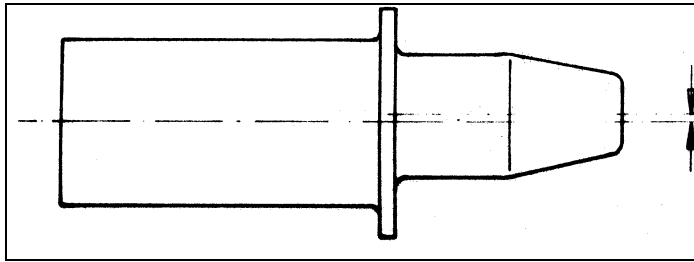
Sketch 1: eccentric drag pin

There are bolts available
with 0,5mm and 1,0mm
eccentricity

The manufacturer can possibly correct twisted ailerons or flaps with a careful heat treatment. A misalignment of the wings can be corrected by fitting special drag pins. On request the manufacturer can supply drag pins which are either 0.5 or 1.0 mm out of centre. For further details please refer to sketches 1 and 2 below.

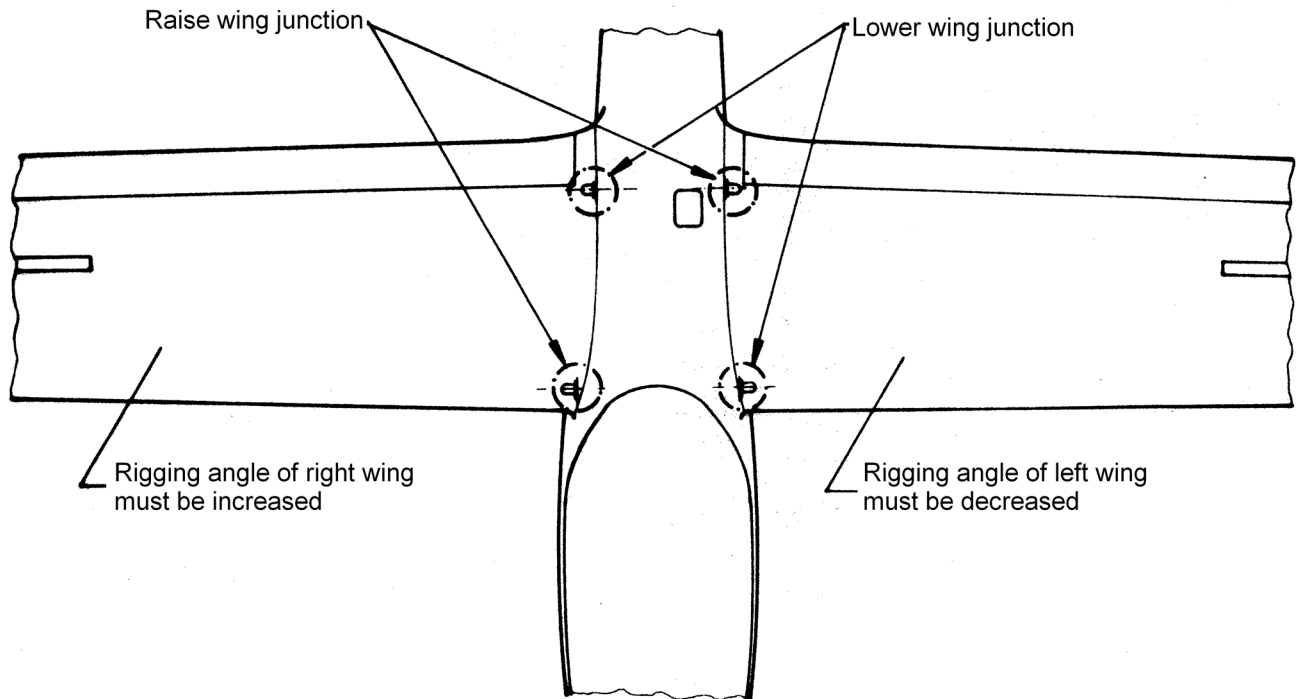
Sketch 2: Glider turns right with controls free, i.e. in straight and level flight, the stick must be pushed to the left.

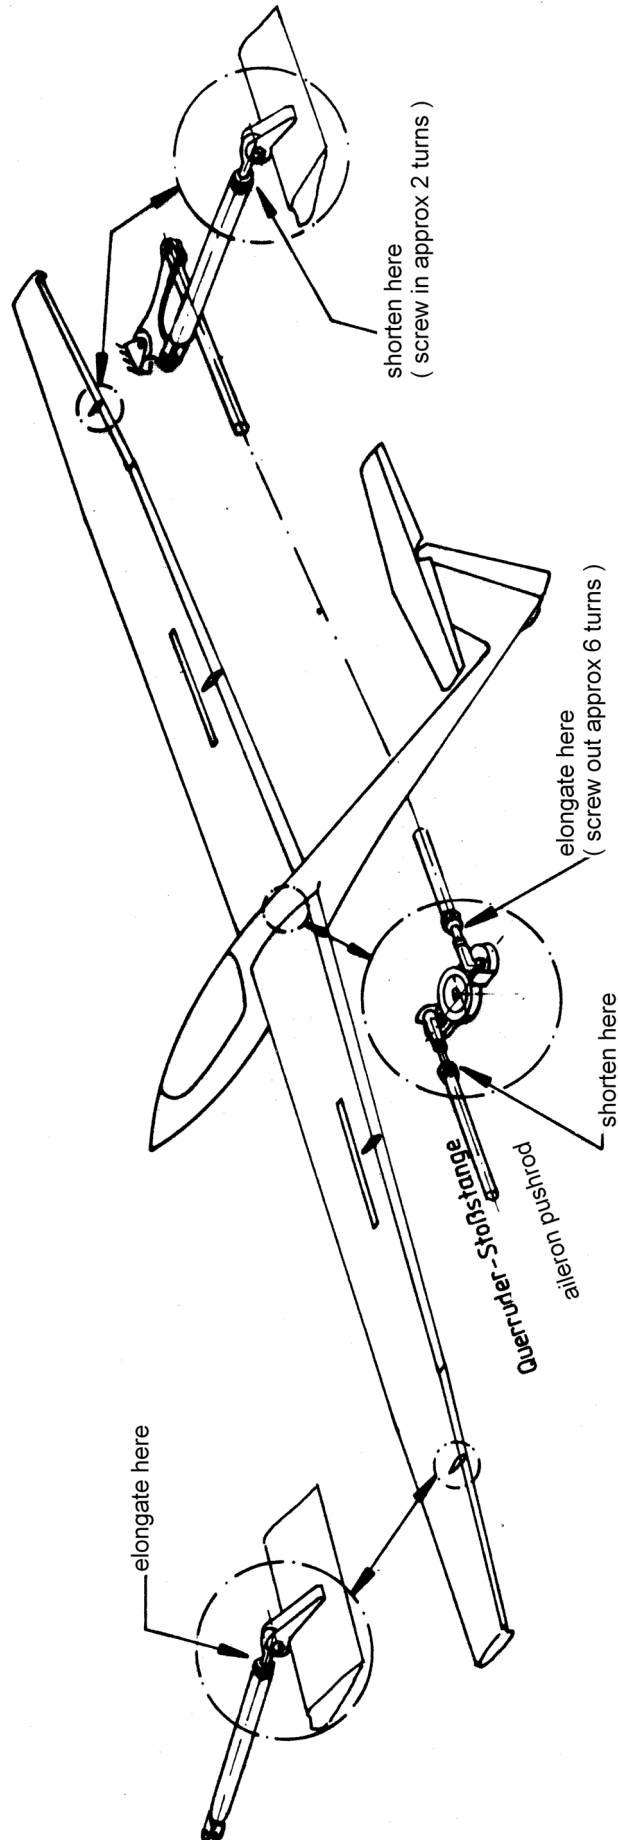
Sketch 3: Modification of the aileron differential according to action 4.b.

b) If the control deflections (in flap setting 3) are almost identical on both wings but flight tests (at the same speed) confirm a stronger tendency to turn in a particular direction in flap setting 1 compared to flap setting 2, the likely reason is a problem with the control linkage inside the wing. A correction as per sketch 3 is required.

Glider turns rather to the right in flap setting 1, i.e. for straight and level flight the stick must be pushed to the left.
In this case the sketched work procedure is applicable.

It is imperative to ensure that enough thread remains in the pushrod ends. Checks using the feeler holes are always required.
